### **Arkema Facility - Harvey Response**

Crosby, TX
Arkema Inc.
September 4, 2017
Project #109489 Summary

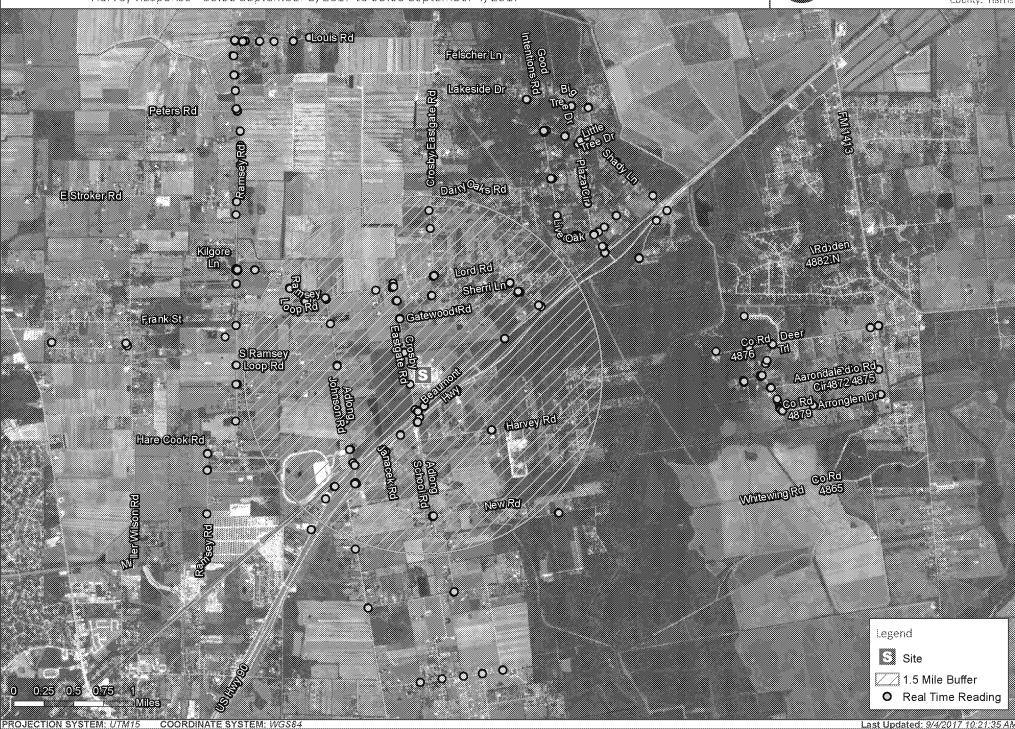
### Hand-held Real-time Reading Locations

All real-time air monitoring instrumentation was calibrated per the manufacturer's recommendations prior to air monitoring. Handheld, real-time air monitoring was conducted for benzene and volatile organic compounds (VOCs) using RAE Systems UltraRAE and MultiRAE instruments. Additionally, combustion byproducts potentially associated with fire smoke, such as particulate matter (PM<sub>2.5</sub>), nitrogen dioxide (NO<sub>2</sub>), and sulfur dioxide (SO<sub>2</sub>) were assessed using Gastec Tubes, DustTraks, and AM510s. **Table 1** summarizes the data for all real-time air monitoring readings recorded in Crosby, TX from 06:00 on September 3, 2017 through 06:00 on September 4, 2017. Maps of real-time air monitoring locations are provided as **Attachment B**.

Harvey Response - 06:00 September 3, 2017 to 06:00 September 4, 2017

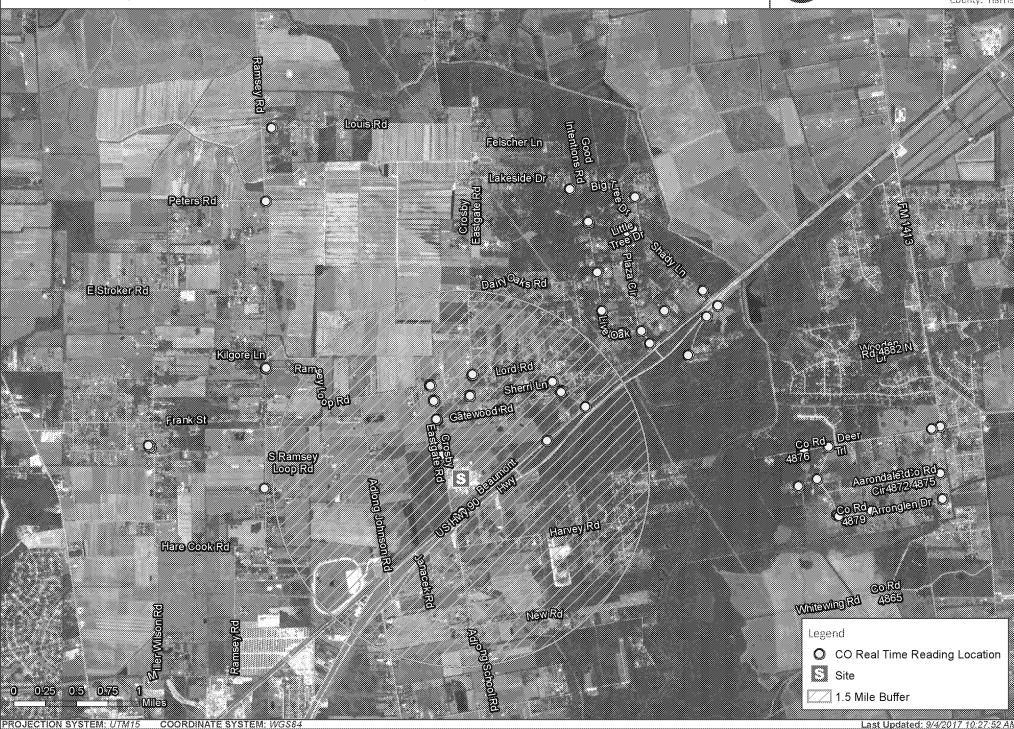
#### Carbon Monoxide Hand-held Real-time Reading Locations

Harvey Response - 06:00 September 3, 2017 to 06:00 September 4, 2017

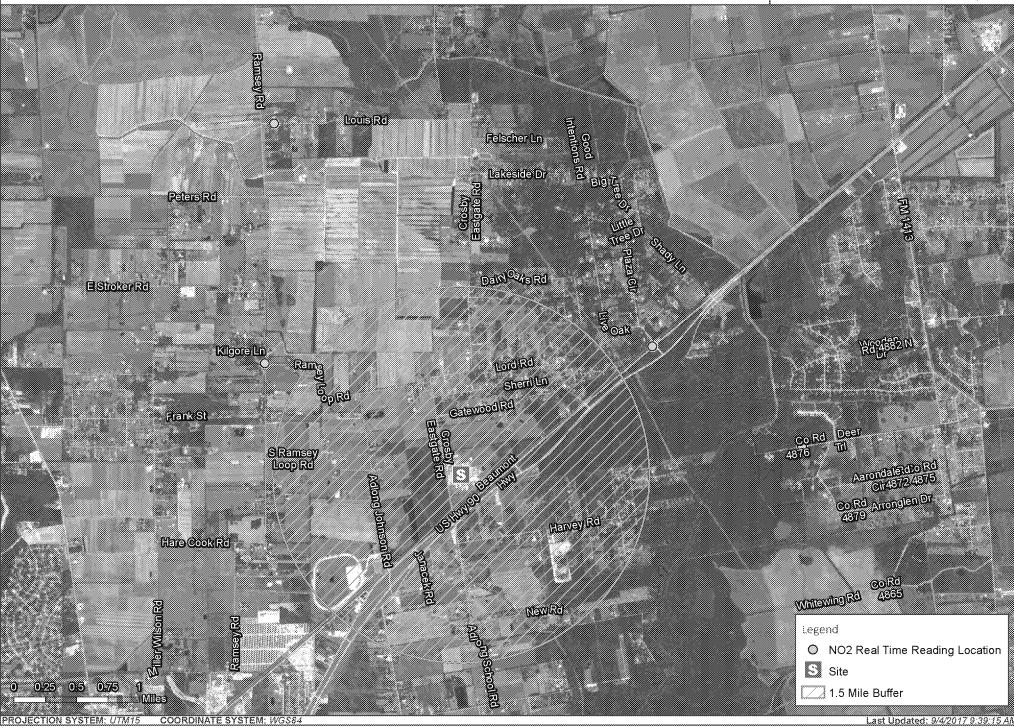
### Nitrogen Dioxide Hand-held Real-time Reading Locations

Harvey Response - 06:00 September 3, 2017 to 06:00 September 4, 2017

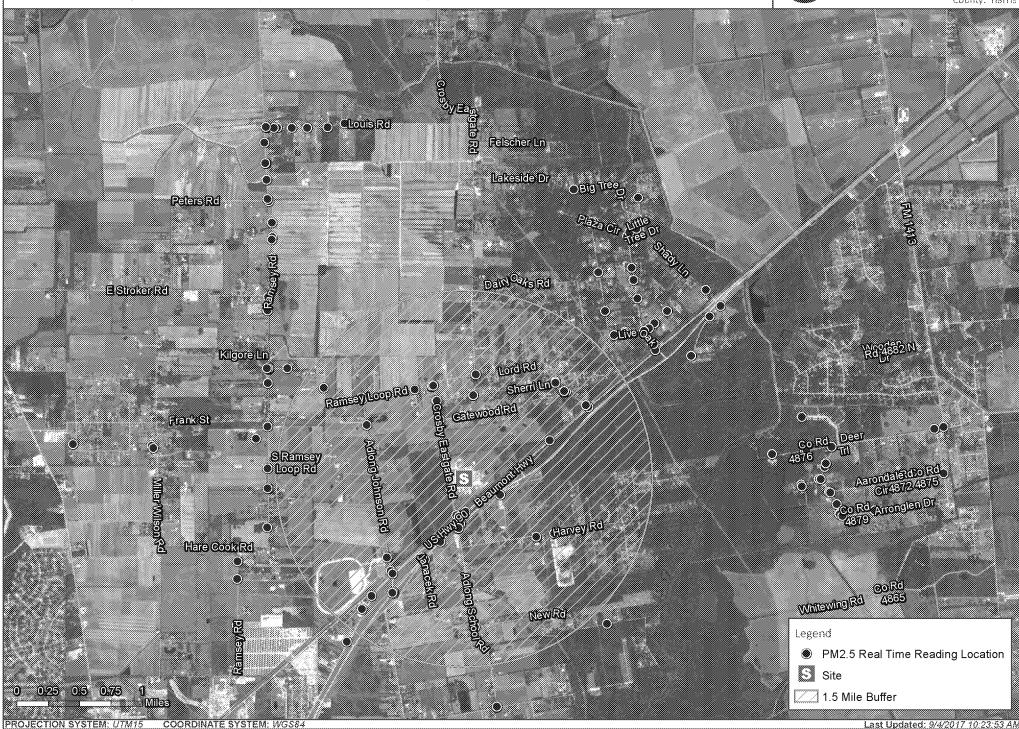
#### PM2.5 Hand-held Real-time Reading Locations

Harvey Response - 06:00 September 3, 2017 to 06:00 September 4, 2017

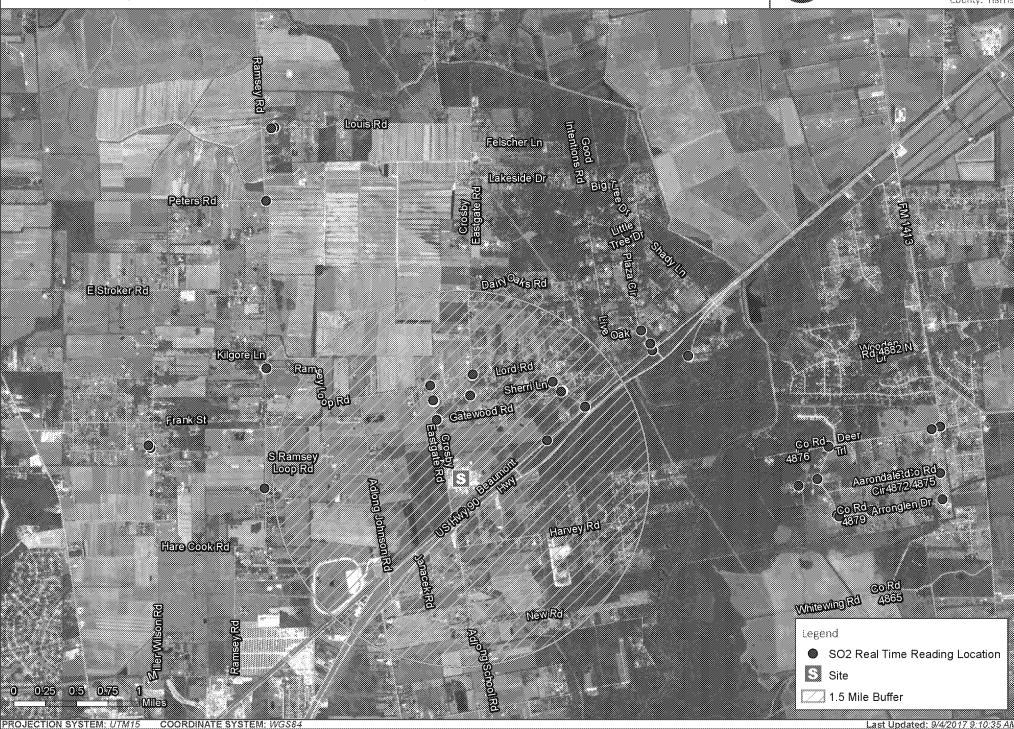
#### Sulfur Dioxide Hand-held Real-time Reading Locations

Harvey Response - 06:00 September 3, 2017 to 06:00 September 4, 2017

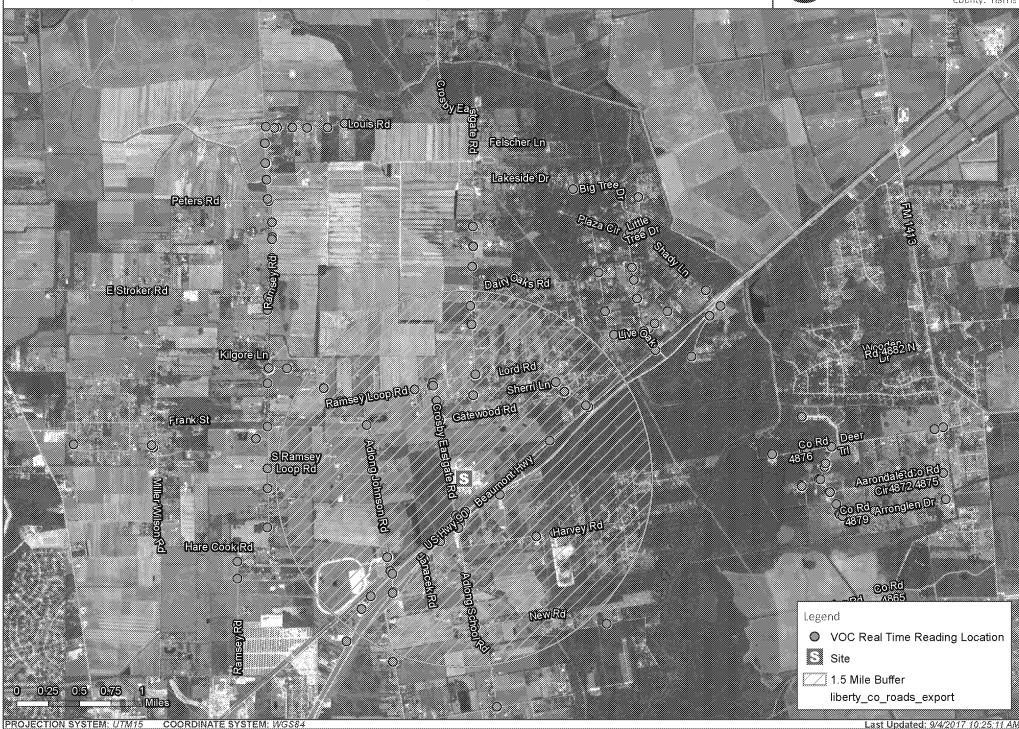
VOC Hand-held Real-time Reading Locations
Harvey Response - 06:00 September 3, 2017 to 06:00 September 4, 2017

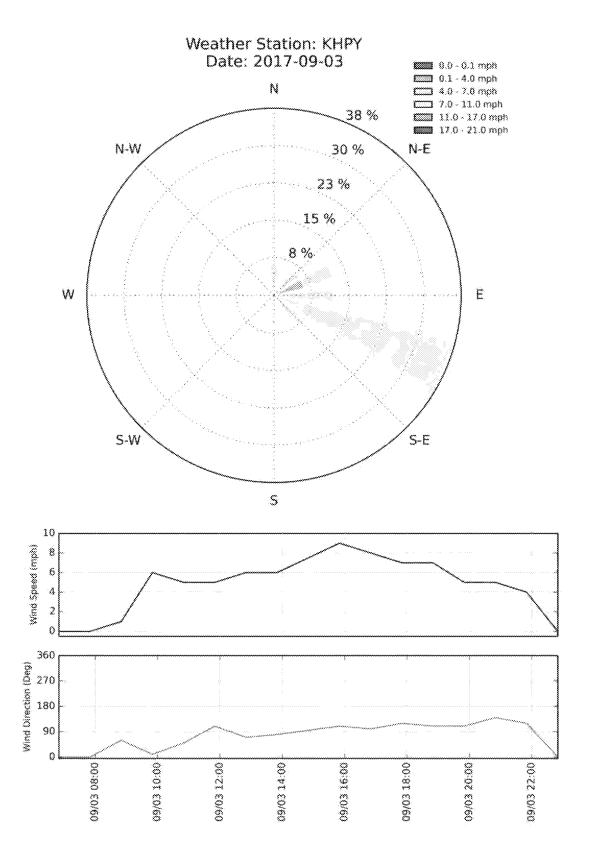
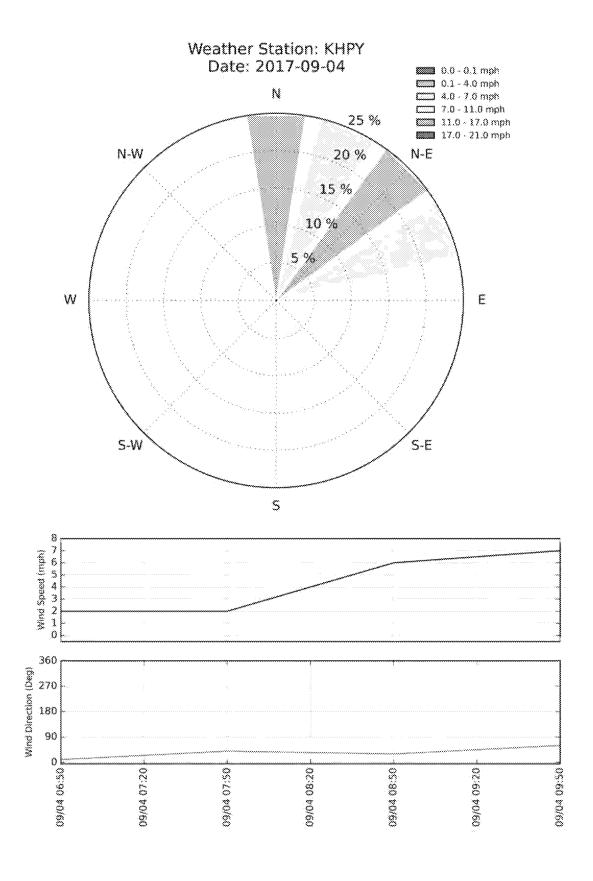
## Attachment D KHPY Windrose

(Highland Park Airport - 12.5 miles SSE of Site)
